MATRIX UPDATE

USB DRIVE BUG FIX

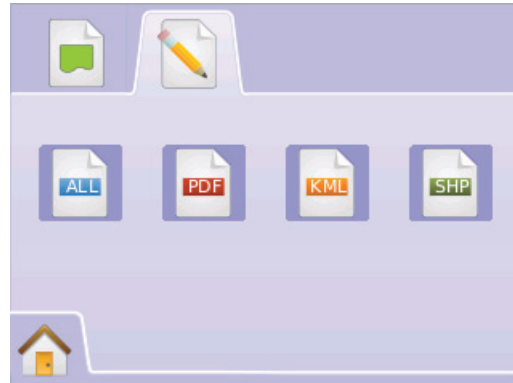
If you do not have a USB Drive inserted into your unit and the Reports icons are enabled your unit has the problem. (Icons are enabled when they are in color and are able to be pressed. An icon that is in grayscale is disabled.)

Figure 1-1: YOU HAVE A PROBLEM IF YOU SEE COLORED ICONS

1. Download the zip file "fix-USBdrive.zip" directly to your computer's Desktop or Downloads folder (see "How to download ZIP files.pdf" for details).
2. Double click the zip file then select either A or B:
 - A) Copy and paste the "tjrun" folder to the root directory of an empty USB drive.
 - B) Using the "Extract all files" function, unzip/uncompress the downloaded file to the root directory of an empty USB drive (see "How to download ZIP files.pdf" for details).
 Once downloaded and unzipped, you will see the folder "tjrun" on your USB drive.
 RECOMMENDATION: Use an empty USB drive. Be sure there are no other automatically executable files on the drive.

3. Properly eject the USB drive from your computer using the "Safely Remove Hardware" icon from the Task Bar or the "Eject this disk" function from the My Computer window or the "Eject Disk" option (on a MAC).
4. With the console OFF, lift rubber cover and insert the USB drive into the Matrix console.
5. Press the Power Button to turn the console ON.

6. When prompted, remove USB drive from the Matrix console.
7. Press and hold the Power On/Off Button for five (5) seconds to power down the console.
8. Press and release the Power On/Off Button to power-on the console again.
9. Verify your update has installed by going to the Save Information Tab with no USB Drive in the console and check that the report icons are disabled.
 - ▶ If the splash screen appears in step 5 and the verification check in step 9 does not pass, re-run the resolution process from step 1.
